Appendix A

Plan Sheets and Typical Cross-Section Drawing of Project Components

COASTAL STORM RISK MANAGEMENT FEASIBILITY STUDY FOR THE SOUTH SHORE OF STATEN ISLAND

PHASE 1 FORT WADSWORTH TO OAKWOOD BEACH

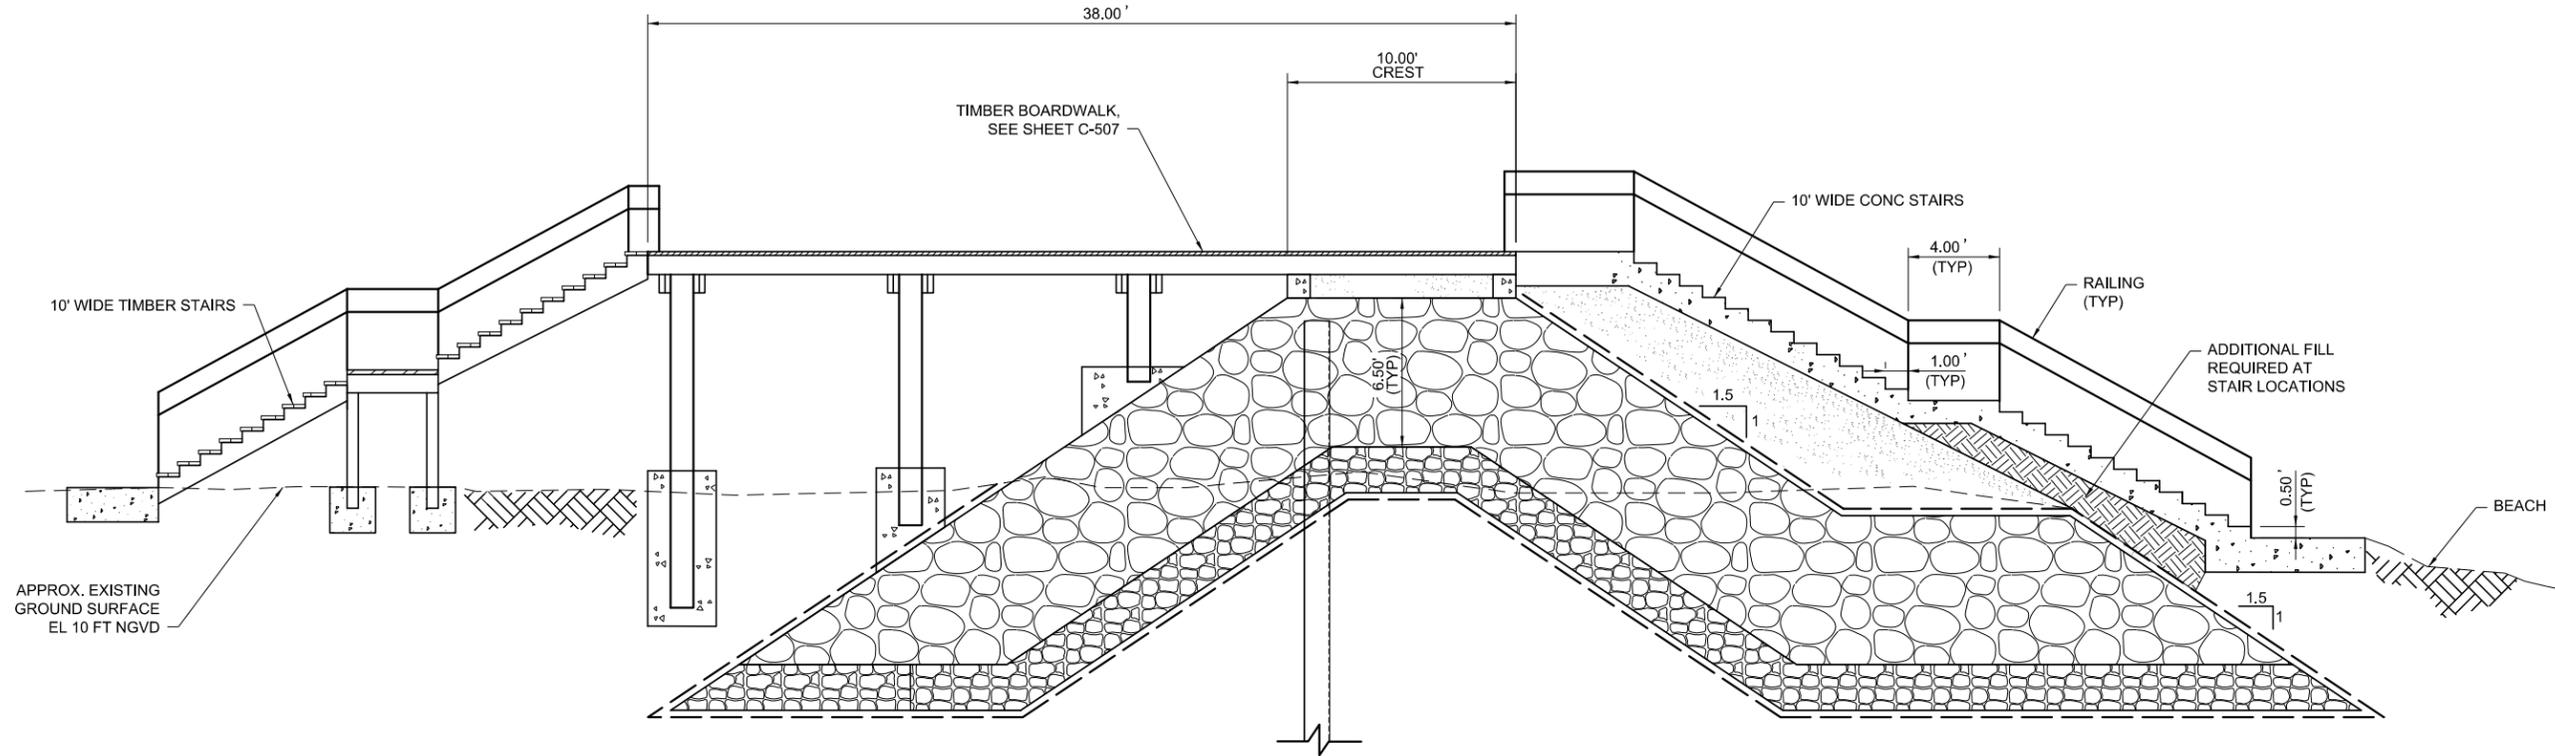
B2 TYPICAL SECTION - PEDESTRIAN ACCESS STAIRS
 C-509 SCALE: 1/4"=1'-0"

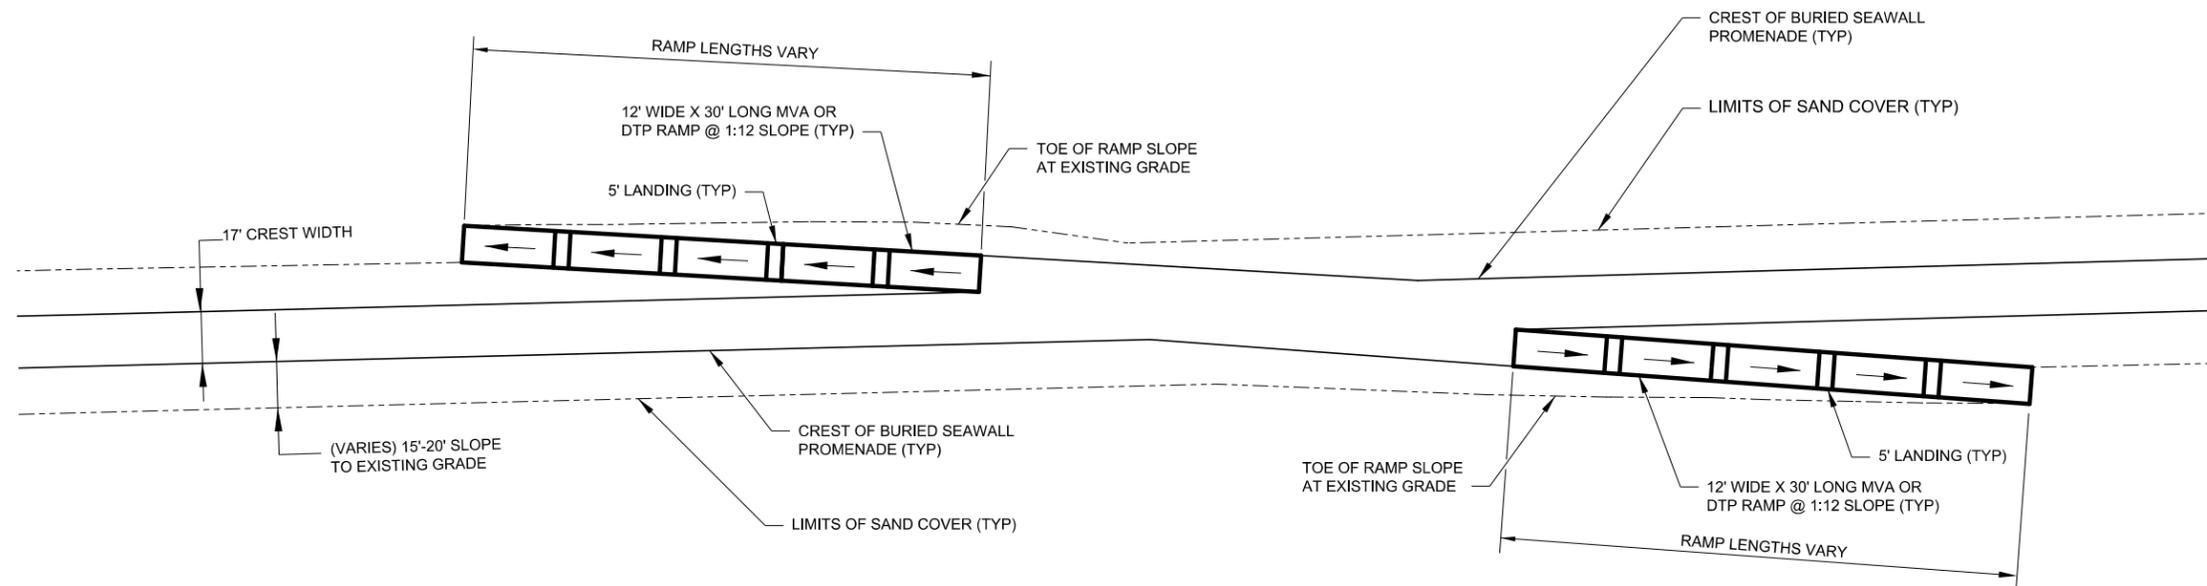
C1 PLAN - TYPICAL MVA AND DTP RAMP DETAIL
C-510 NOT TO SCALE

1. RAMP SHOWN IS A TYPICAL CONDITION.
 RAMP GEOMETRY MAY VARY BY LOCATION.

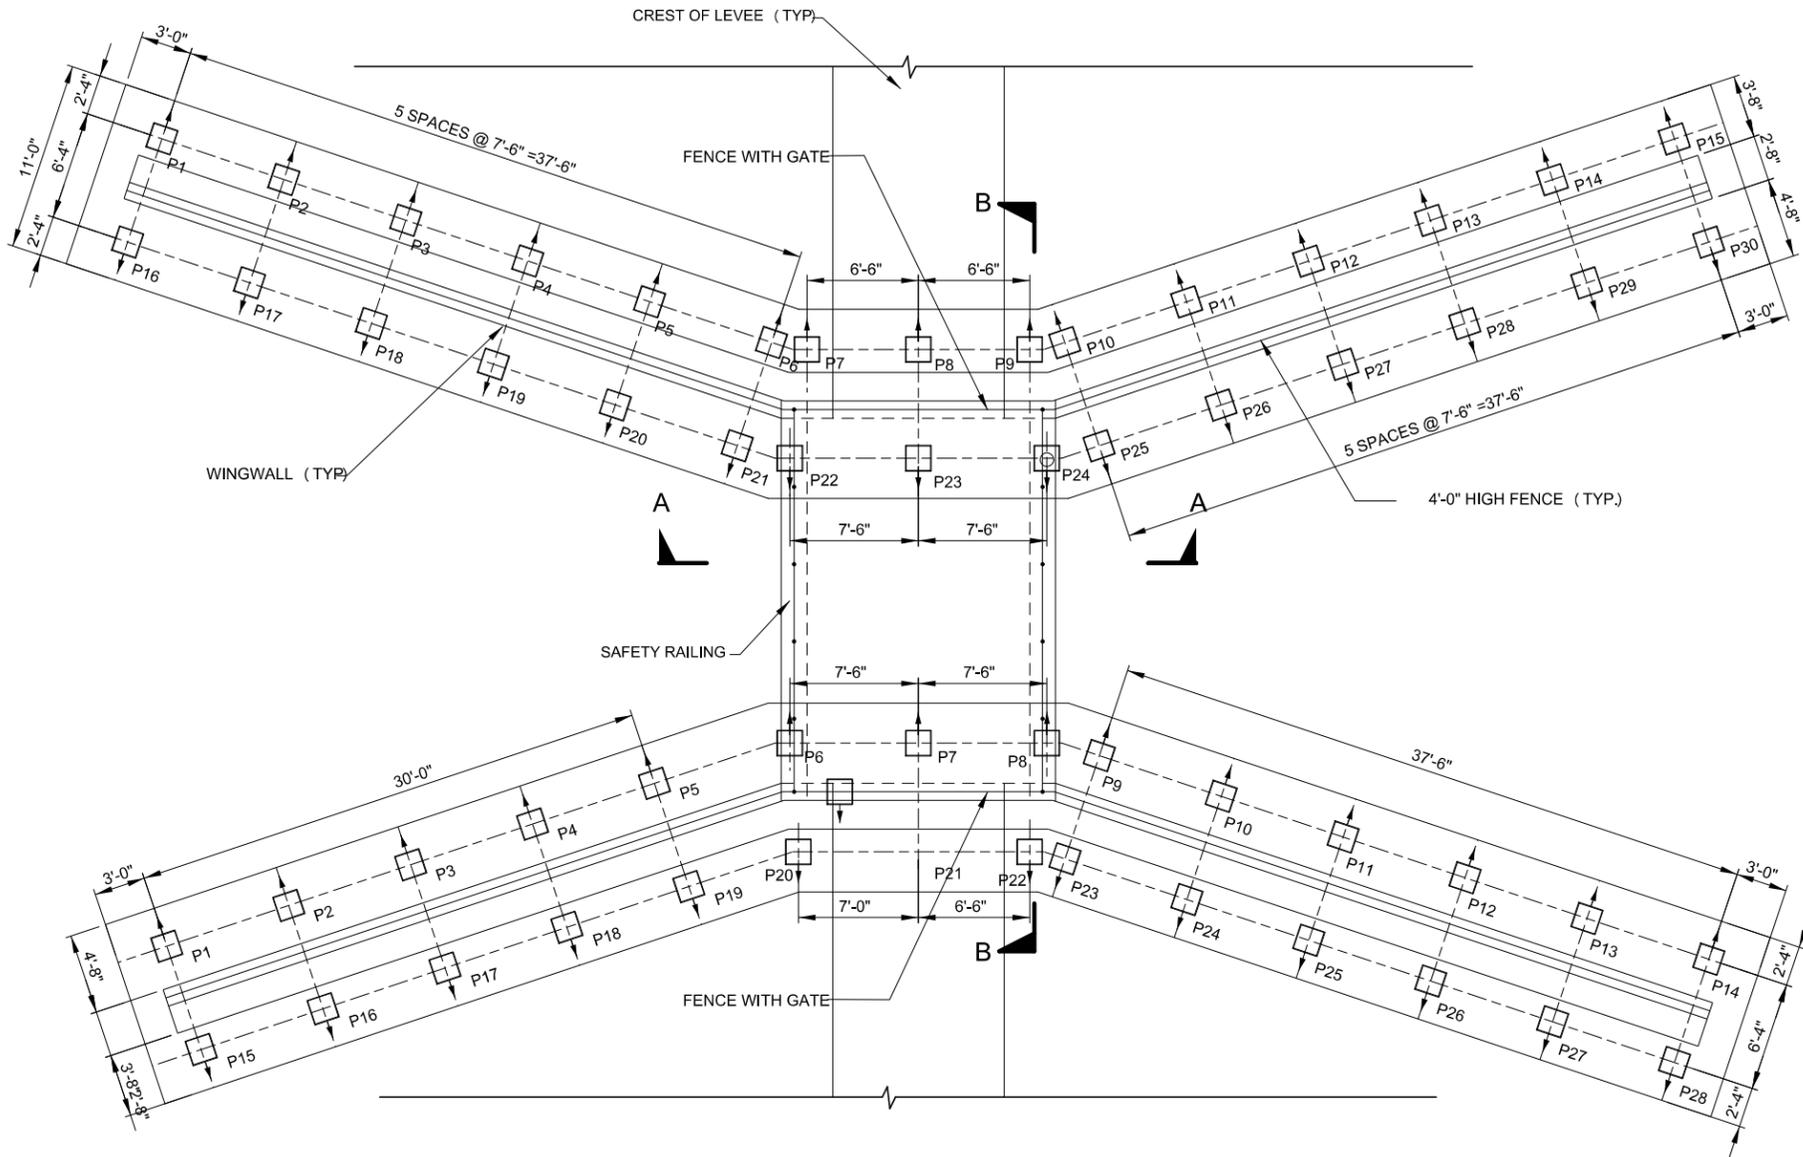
C PLAN
C-513 SCALE: 3/16"=1'-0"

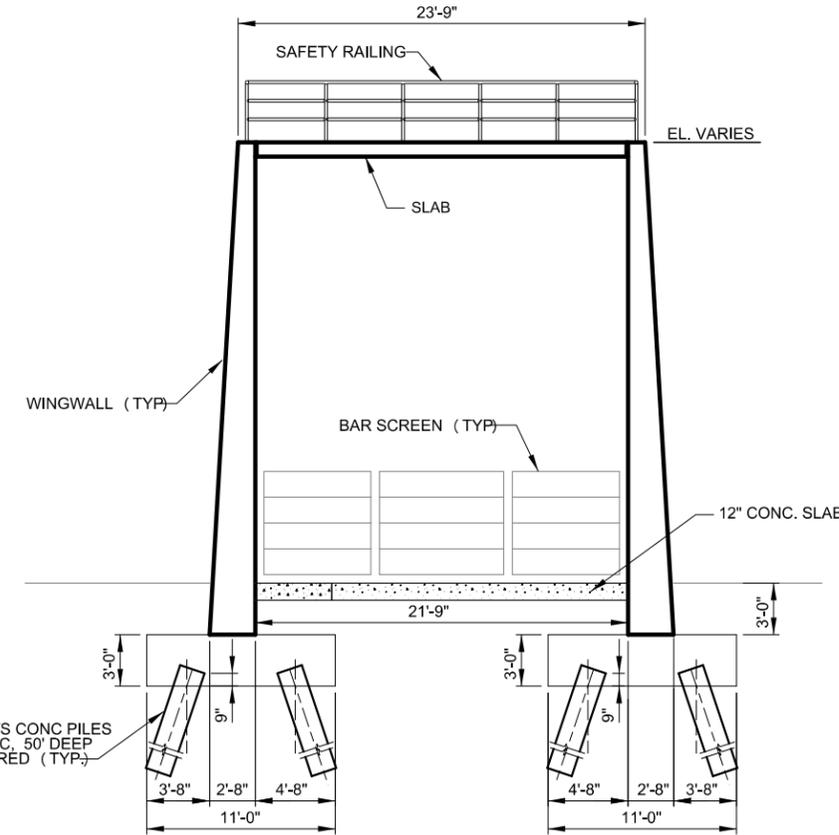
B LONGITUDINAL SECTION
C-513 SCALE: 3/16"=1'-0"

18" SQ P/S CONC PILES
@ 7'-6" OC, 50' DEEP
STAGGERED (TYP.)

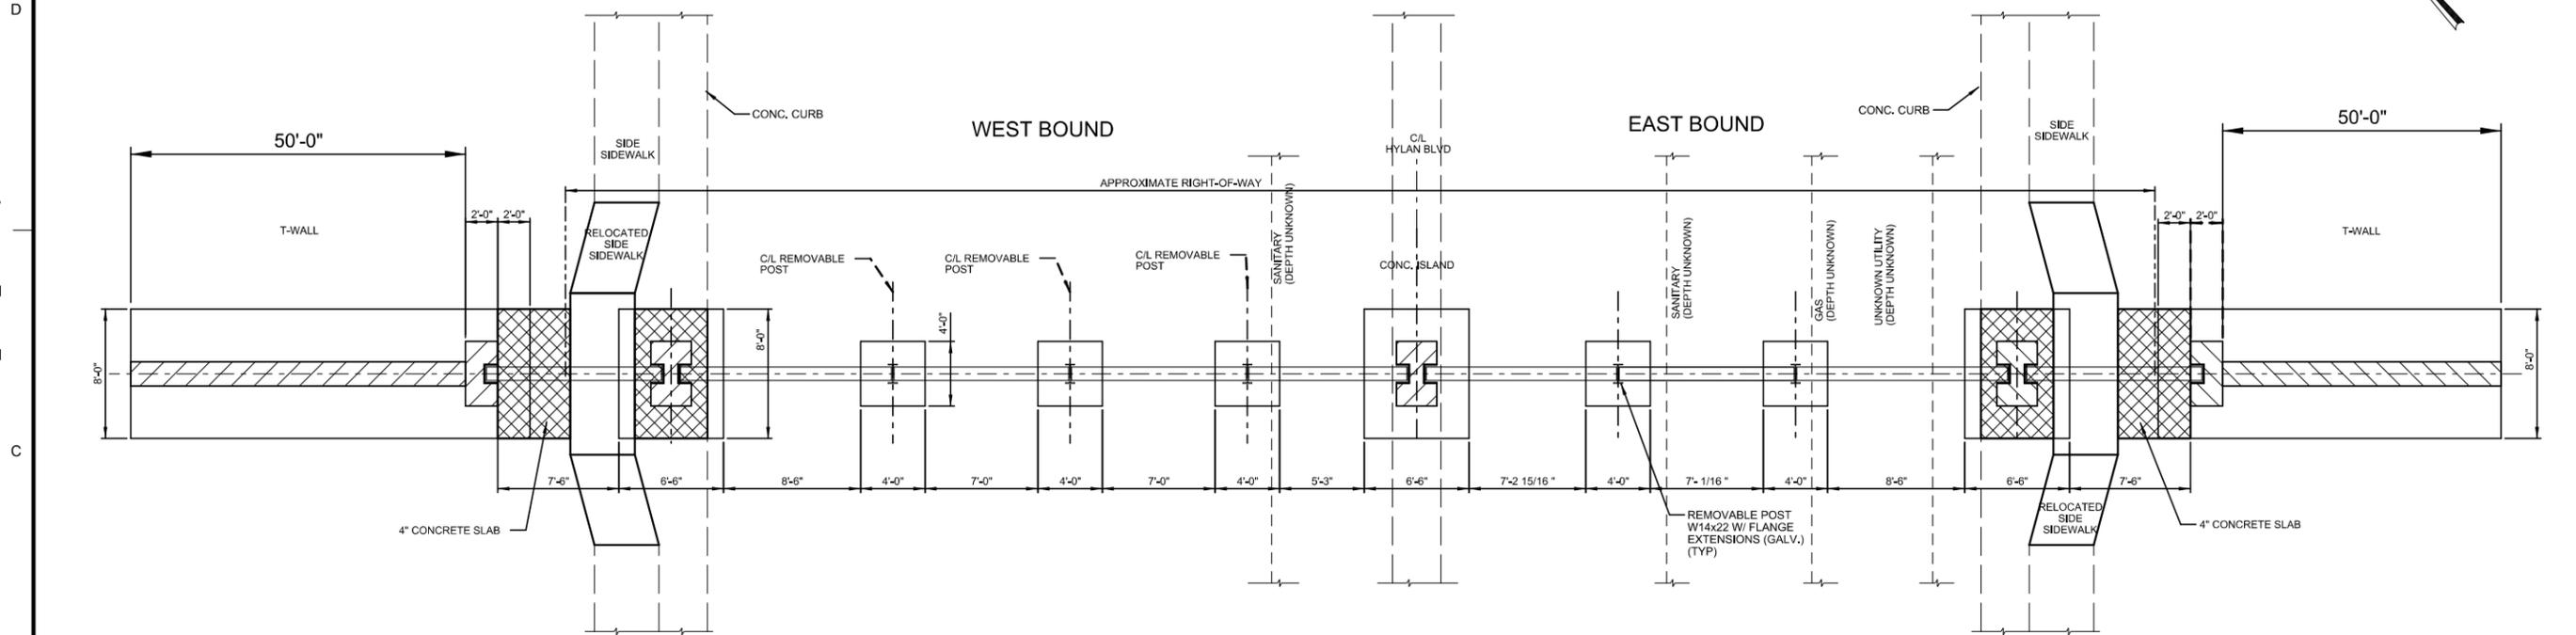
B PLAN VIEW
 C-515 SCALE: 3/16"=1'-0"

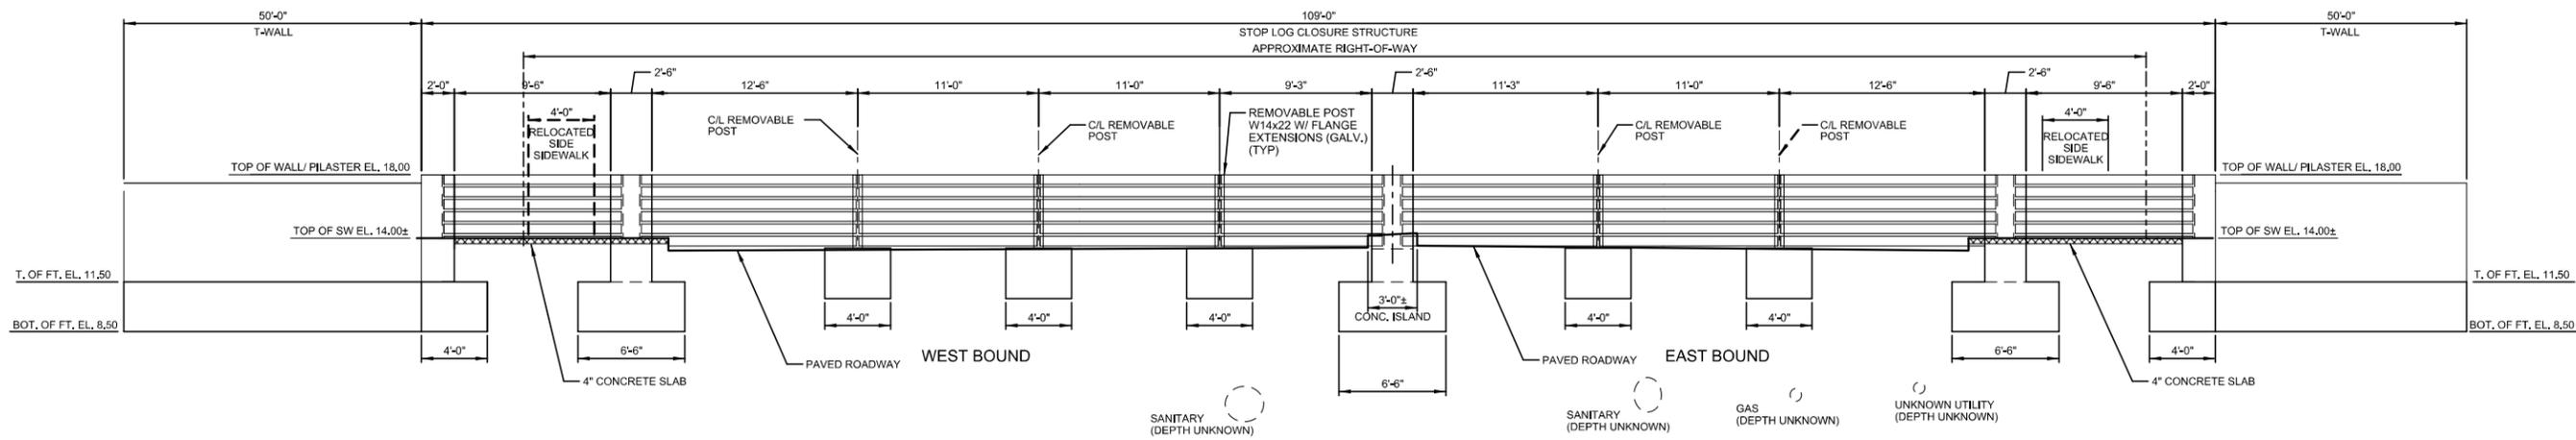
A ELEVATION - FLOODWALL/BULKHEAD CLOSURE STRUCTURE - (ELEVATIONS ALONG C/L WALL)
 C-515 SCALE: 3/16"=1'-0"

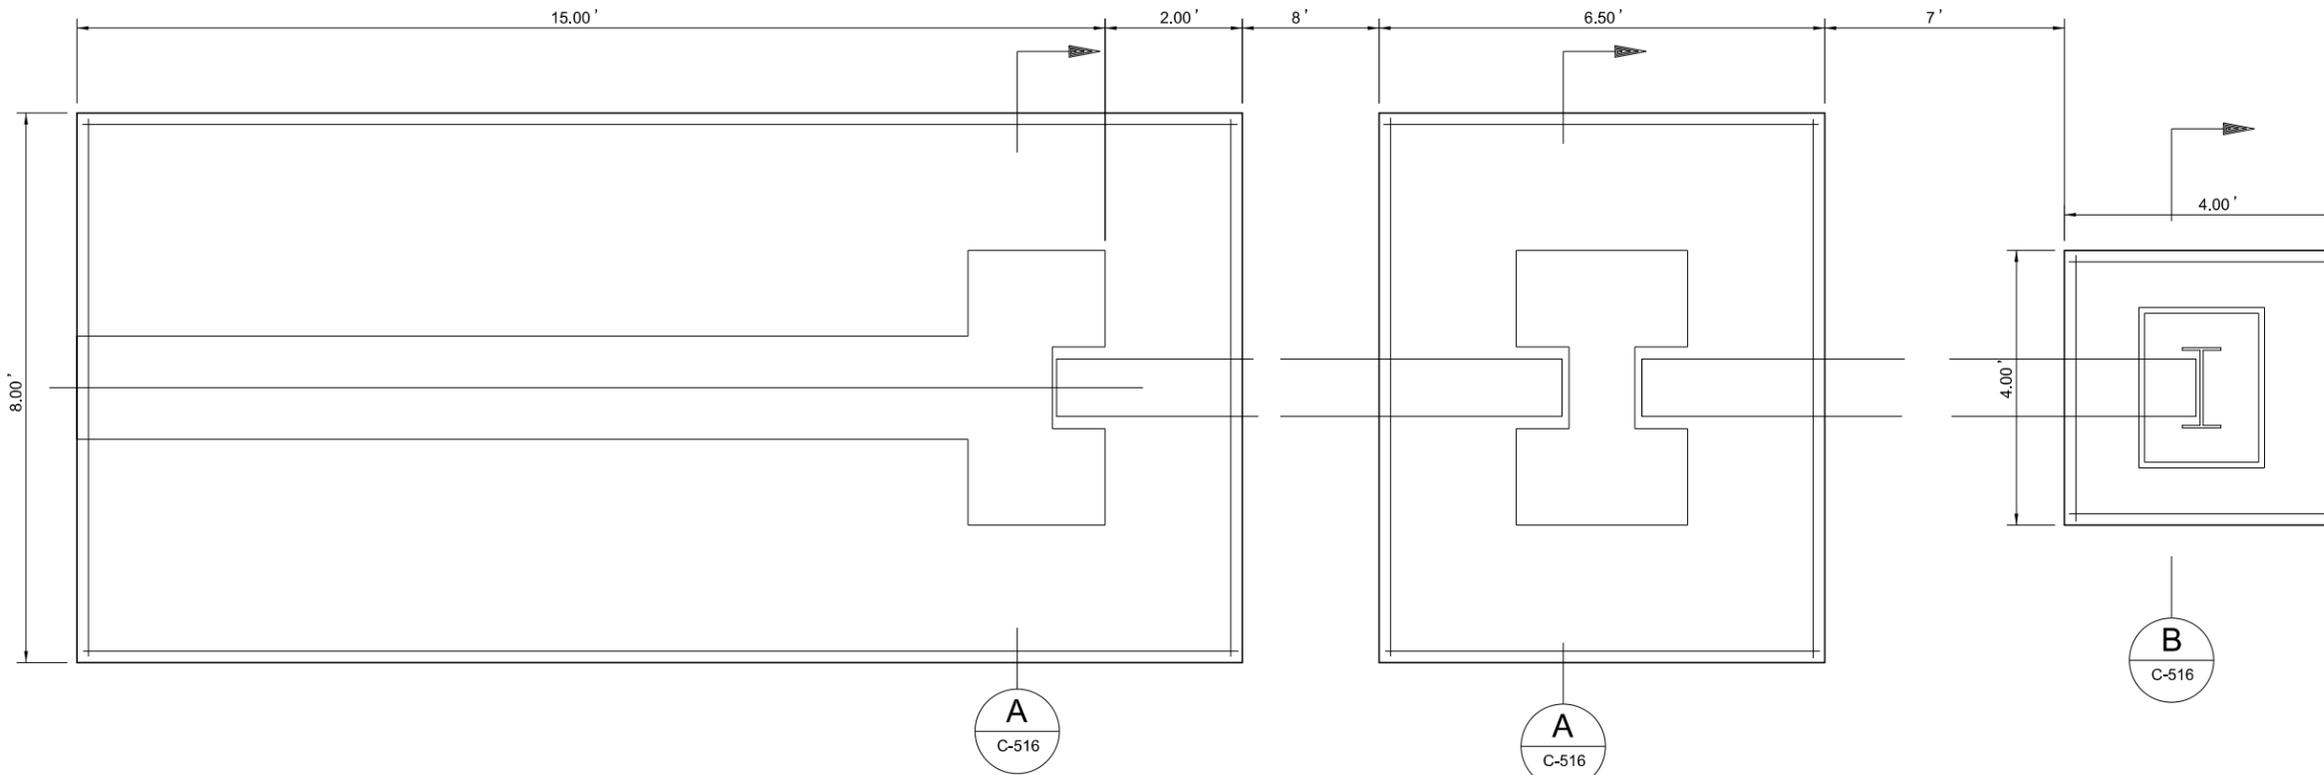
D PLAN
C-516 SCALE: 3/4"=1'-0"

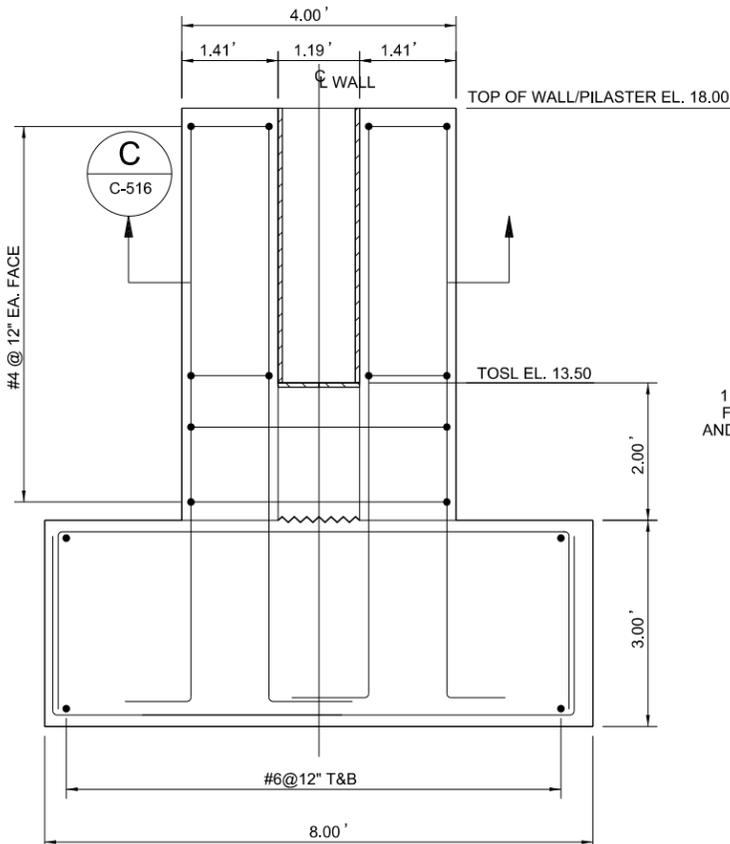
A SECTION
C-516 SCALE: 3/4"=1'-0"
